# Experimental Investigation of Thermal and Hydrodynamic Effects on Radially Grooved Thrust Washer Bearings

*In this study, an experimental investigation on the effects of grooves on thrust washer bearings is investigated. Eight equally sized grooves are machined about 100  $\mu\text{m}$  deep into one side of a flat-faced steel washer. This thrust washer bearing is located between a helical gear and its carrier and is tested on a test rig capable of measuring frictional torque and the temperature of the bearing at different speeds. It is found that the grooved washers had lower bearing temperatures and failed at significantly higher loads than the control washer with no grooves. For a test procedure with varying operating conditions, the coefficient of friction is also significantly lower for the grooved washers. However, the grooved washers had about the same coefficient of friction as the control washers at each step when the speeds are very high. The results from various tests suggest that the increased amount of lubricant passing through the grooved surface of the washer removes heat from the washer bearing by convection. This decrease in stored heat conducted from friction d

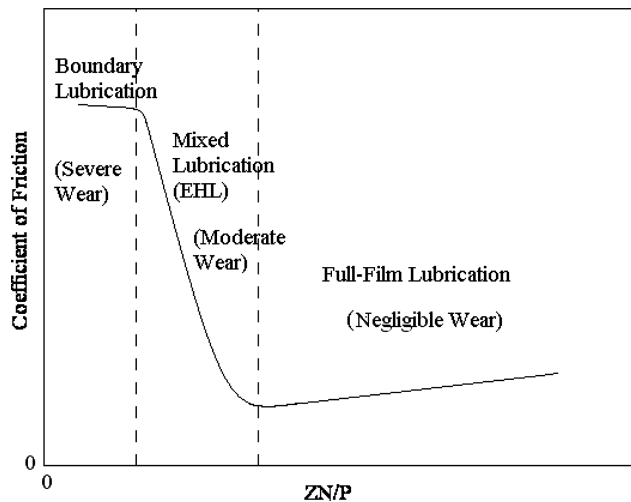
Fig. 4—Typical Stribeck curve.

A typical Stribeck curve is shown in Fig. 4. If the bearing operates on the far left side of the curve, then it experiences boundary lubrication and asperity contact. If the bearing operates on the far right side of the curve, where  $f$  is smaller, the bearing likely has a full film of lubrication separating the surfaces. Transition from mixed lubrication to full-film lubrication is marked by a “knee” at the minimum coefficient of friction.

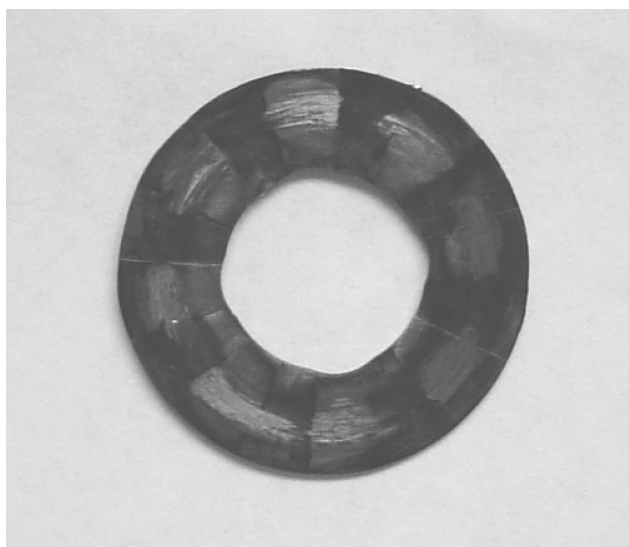
Fig. 6—Picture of worn grooved washer after run for procedure 1.

trol washer. As seen in Fig. 5, the effective coefficient of friction for the grooved washer is consistently smaller than that for the control washer. Figure 6 shows the failed grooved washer, and although the grooves are still present, much of the virgin surface has significantly been worn off. The data and Stribeck curve generated for an additional (repeated) test are found in Table 5 and Fig. 7, respectively. The results for the second test show the same trend

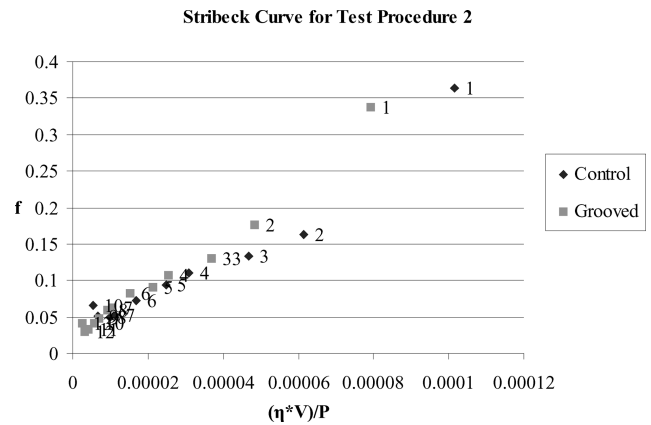
Fig. 8—Stribeck curve for test procedure 2.

Test procedure 2 is run for the control and grooved thrust washer bearings. The resulting Stribeck curves are shown in Fig. 8 and their respective data are given in Tables 6 and 7. The time of failure for the control washer is 45:26 at step 10 and the grooved washer failed at 1:00:51 at step 13. The effective coefficient of friction for the grooved washer is slightly larger than that of the control; however, it also failed at a load of 636.6N, which is more than twice as large as the load at step 10. The slightly higher fric-

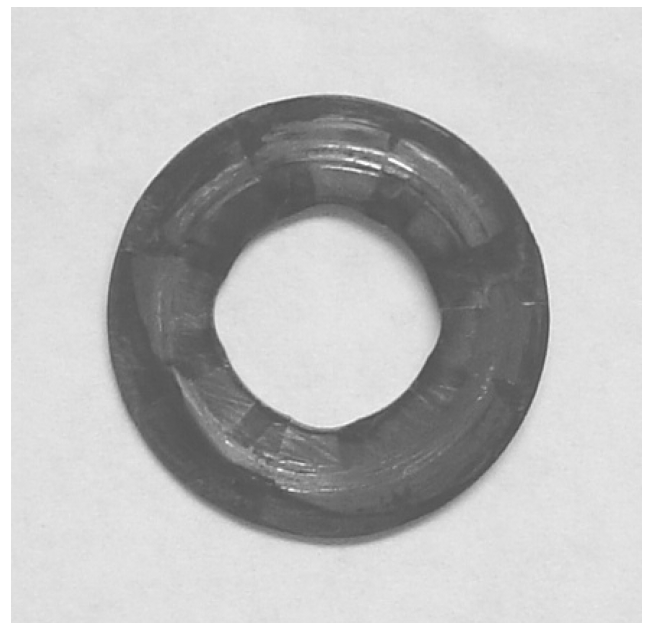
Fig. 9—Picture of worn grooved washer after run for procedure 2.

The grooved washer is also shown in Fig. 9 after the test is run. As expected, it appears that this washer is more severely worn than the washer tested in procedure 1 (see Fig. 6). Figure 10 shows a comparison of several SEM pictures taken of the two washer surfaces which also confirms this. The SEM images show that there is significant smearing and gouging of the washer surfaces that is typical of scuffing during TEI and TVD failure. There appear

to be deeper wear grooves and gouges in the washer run under procedure 2 than procedure 1, but it is apparent that both washers failed severely. Because the washer is running at a higher speed in procedure 2 the TEI and TVD failure may have been more severe for procedure 2. The higher speeds cause higher temperature on the surfaces and thus increase the occurrence of scuffing. Still, the grooved washer failed at a higher load because the grooves allowed an increased amount of lubricant to pass along the surface of the washer. This allows the lubricant to carry heat caused by friction away by convection and the occurrences of hot spots are decreased. While thermoviscous distress (TVD) effects are larger because of the higher rotational speed, the occurrence of TEI is decreased because of the increase in lubricant flow across the surface of the washer. The data and Stribeck curve generated for an additional test are found in Table 8 and Fig. 11, respectively. The results for the second test of procedure 2 show the same trend as the first test, but by comparison it has slightly larger variations (than those reported for procedure 1 set of tests). Here, the average COF varied by an average of 15.5% between the two tests, with a maximum difference of 36.3%. At failure, the COF varied by 18.0% between the tests. The two tests also failed at precisely the same load increment, suggesting that the tests are repeatable. These relatively small variations can again be attributed to manufacturing variations and assembly of the washers in the rig and the slight changes in the test conditions due to wear of the test of apparatus.
